Knapps Creek Demonstration Project

Introduction

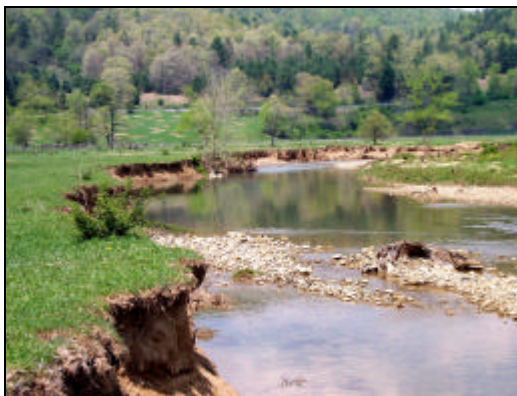
Photo 1, Pre-construction: View is looking upstream at the starting point for Site 24. Note the eroding banks, excessively wide and shallow channel, and deposition of mid-channel bars.

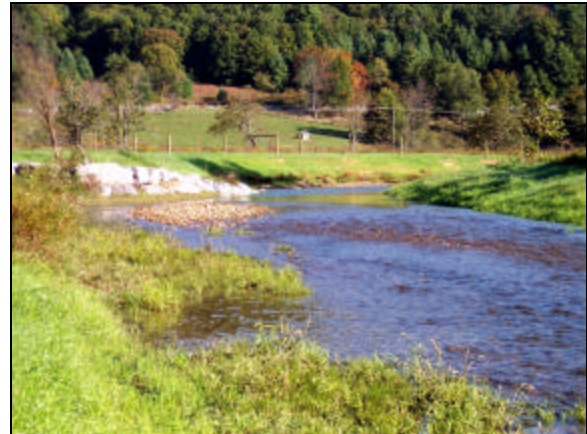
Photo 2, Post-construction (Same area as shown in Photo 1): View is looking upstream at the beginning of the reconstructed channel for Site 24. Natural stream design features include the sloped banks protected by seeding, woody transplants, fence to separate livestock from restored areas, reduced channel width, and a rock vane.

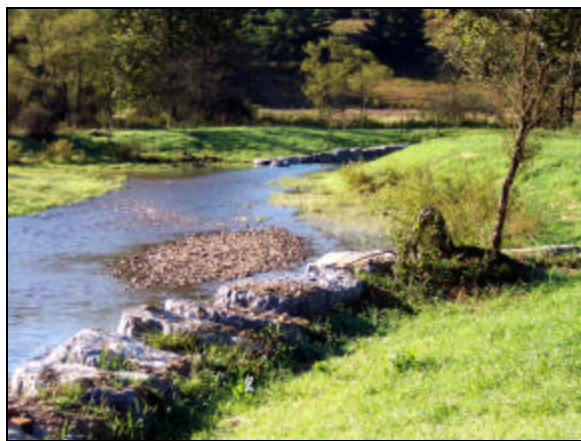
Photo 3, Post-construction: View looking downstream along the beginning of the re-constructed channel. Note the sloped banks with re-established grass, rock vane, and woody transplants to protect the streambank.

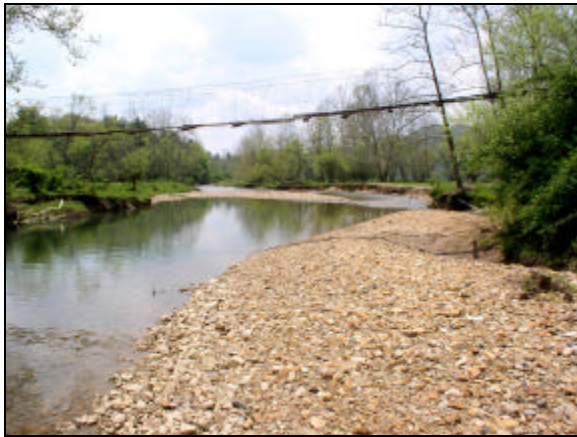
Photo 4, Pre-construction: View looking downstream through the first channel bend. Note the wide, shallow channel, point bar, gravel deposition, and streambank erosion. The landowner uses the footbridge to cross the stream during high flows to care for cattle.

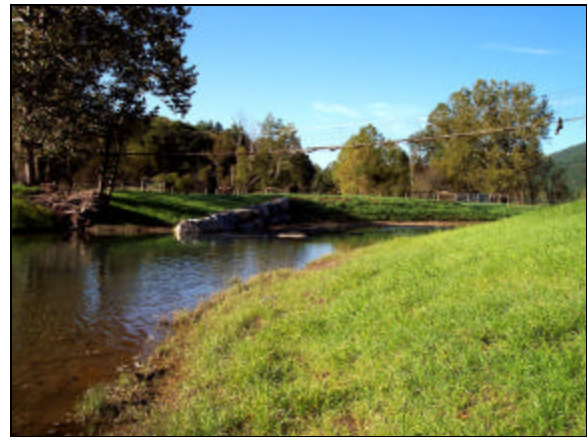
Photo 5, Post-construction: View looking downstream at the same channel as in Photo 4. Note the restored streambank with vegetation and rock vane to protect the bank from future erosion. A new meander was created just beyond the rock vane where the channel had previously been straightened.

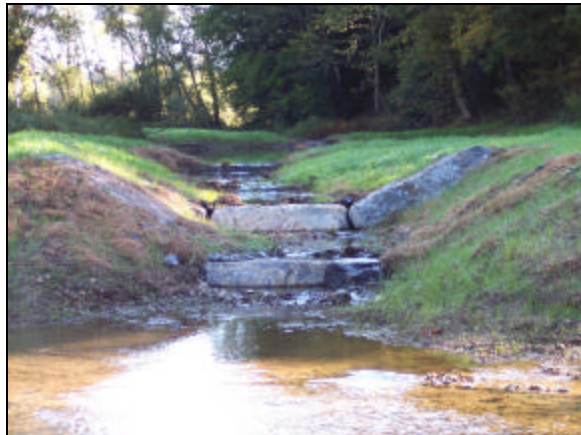
Photo 6, Post-construction: View shows a step-pool outlet channel carrying flow from a new wetland area back into the main channel. The step-pool channel was created using rock sills. The new wetland area was created from a portion of the original channel that had been straightened. The meander was reconstructed to bypass the old straightened channel.

During the restoration of natural meanders, sections of the existing channel were abandoned making a perfect opportunity for the creation of wetlands. Two wetland areas were constructed in these abandoned channel sections. On-site vegetative

materials, transplants, and wetland soils were used as seed sources for the new wetlands. Water levels in the wetlands are controlled by log weirs. Both of the wetlands included the construction of outlet channels using a step-pool design. This stable outlet channel allows the wetland to drain excess water back into the main channel of Knapps Creek.

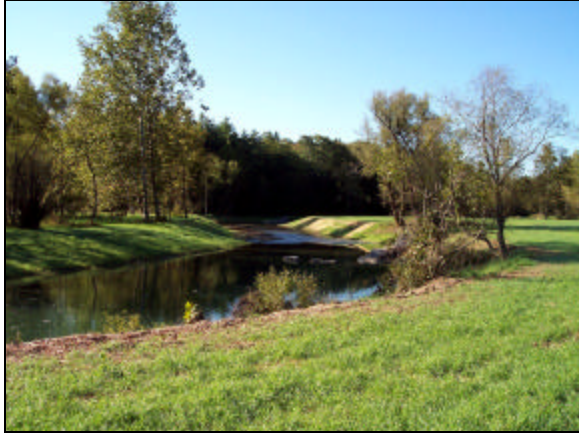
Photo 7, Post Construction: View looking downstream at constructed meander bend. Mature trees were left in place. The riffle-pool sequence was constructed to add diversity in the bottom profile of the stream.

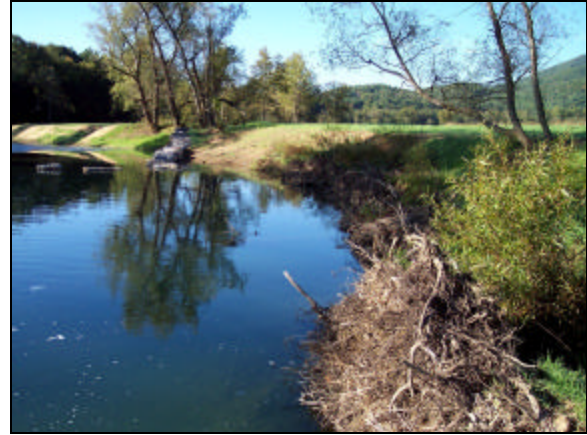
Photo 8, Post-construction (same meander bend as in Photo 7): Photo shows reconstructed portion of channel where the meander was restored. Natural design elements shown are the root wads, woody vegetation (willows), rock vane, and preserved mature trees. The rock vane will protect the bank and maintain pool depth for aquatic habitat diversity.
