Audrey Hedrick

Assessment of a sinkhole-water reservoir in Fort Springs,

WV within the Greenbrier River Watershed

January 7, 2009

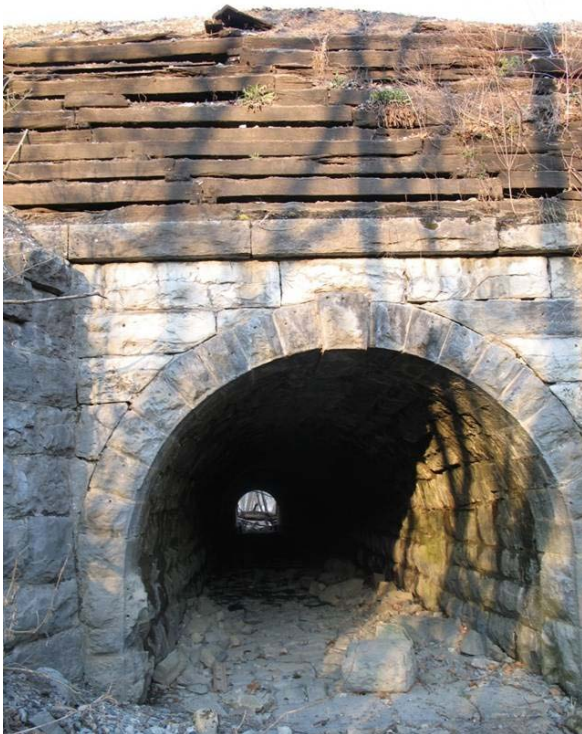
Figure 3: Storm water tunnel

The final portion of the habitat assessment included viewing and researching the history surrounding the local cemetery and the storm water tunnel leading into the Greenbrier River in Fort Springs, West Virginia. The cemetery dates back to the 1800's and is believed to have begun due to the acquirement of typhoid fever within the community due to drinking water from the sinkhole. Typhoid fever is a serious bacterial disease that results in fever, weakness, and in severe cases, death. Typhoid fever is caused by the bacterium *Salmonella typhi* and is passed through contaminated water. The storm water tunnel was originally built in 1872 and is the direct inlet of the sinkhole reservoir into the Greenbrier River. The cemetery and storm water tunnel can be viewed in Figures 2-3.

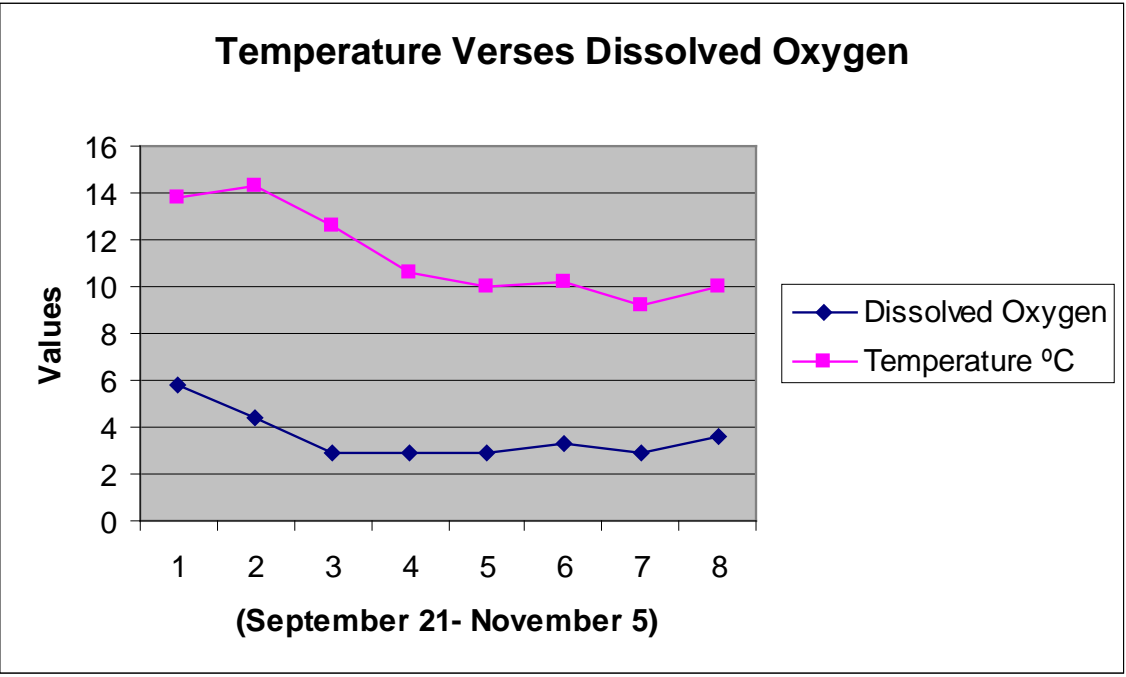
Figure 4: Temperature verses Dissolved Oxygen

Dissolved oxygen levels were found to be between 2.9 and 5.8ppm, which is low according to the West Virginia Department of Environmental Protection standards. Dissolved oxygen levels were directly related to the water temperature. As the water temperature dropped from 14°C to 10°C so did the dissolved oxygen levels (Figure 4).

Dissolved oxygen levels of the reservoir were low according to West Virginia Department of Environmental Protection standards. Dissolved oxygen levels of at least 4-5ppm are needed to support a wide range of aquatic life. There was only one species of fish found

within the reservoir supporting the fact that the low dissolved oxygen levels could not support a wide variety of aquatic life.
